SABOURIN STADIUM

Bedford High School
400m Track & Field Complex Master Plan

August 22, 2023
DRAFT

Re: Bedford Sabourin Field Complex – Master Plan

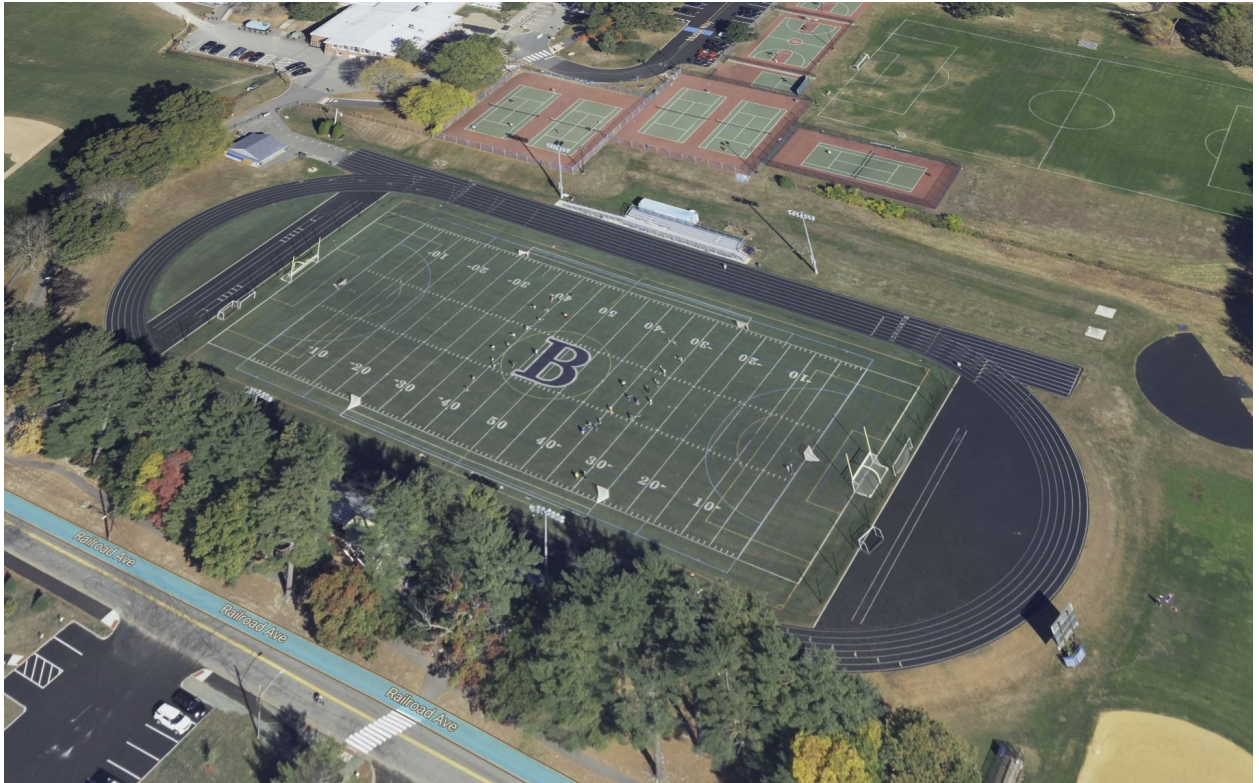
Figure 1 - 400m Track & Field

1. **400m Running Track:** The 400m Track was originally constructed over twenty years ago, and the existing resilient track surface received a spray-applied topcoat and new lane markings in 2013. The track surface has noticeable wear and depression in limited areas. The resilient surface is delaminated in many areas and the asphalt surface is cracking and in need of replacement. The typical life span for a running track with bituminous concrete is twenty to twenty-four years. This track is at the end of its useful life and the Town of Bedford should consider plans for replacement soon.

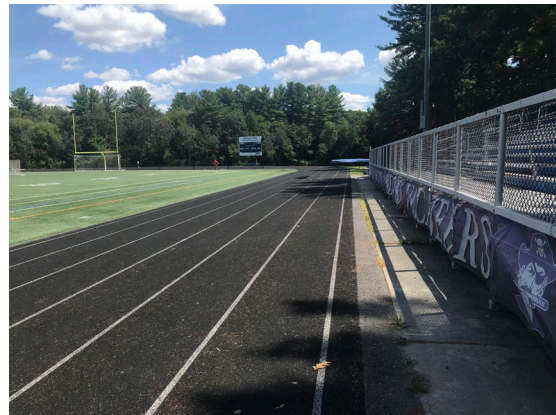
Figure 3 - 400m Track

The running track oval and straight-aways appear to have a solid subbase, with little settlement or heaving noticed throughout the track. The resilient surface is worn, and the asphalt is showing signs of hairline cracks and shrinking, which is normal for an asphalt surface of this age.

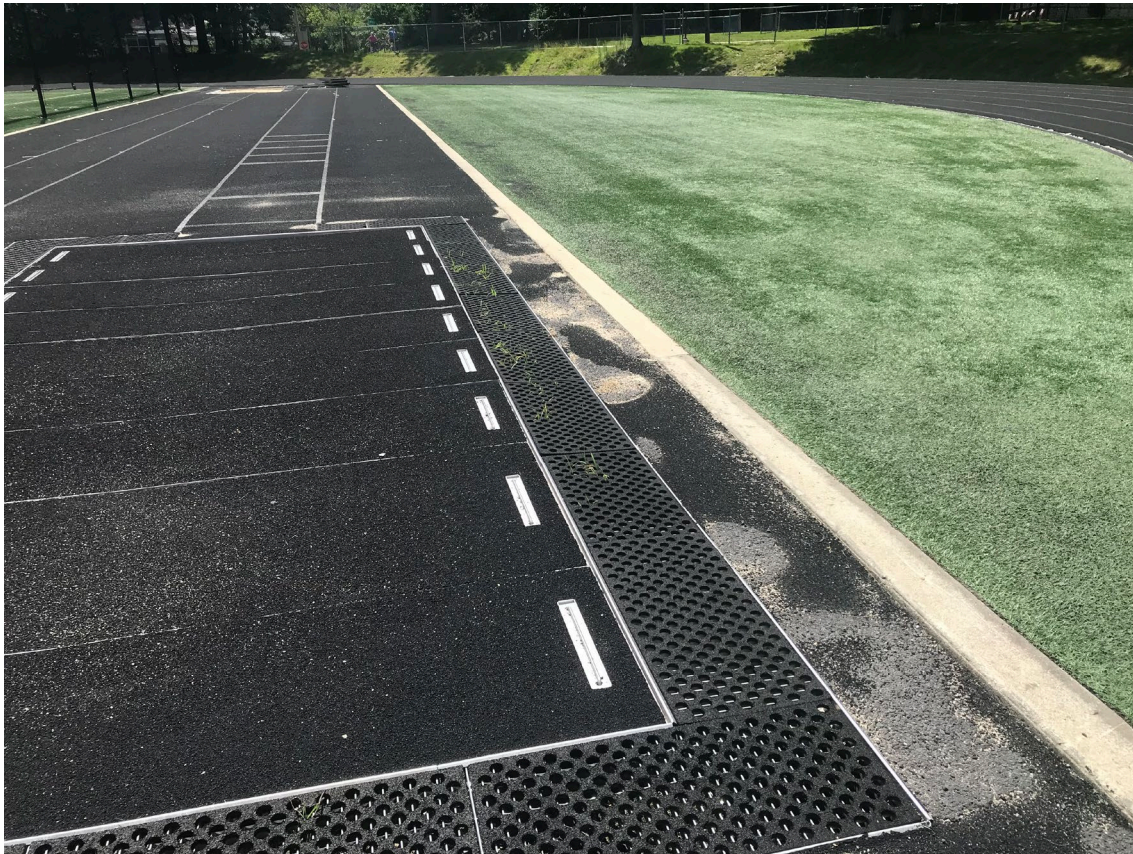
Figure 4 – West ‘D’ Area – Asphalt Settlement

Other observations made at the time of our visit to the 400m Track include the following: 1) the resilient surface is worn and in need of repair/resurfacing. 2) Depressions and settlement of the asphalt base in both ‘D’ areas, 3) The ACO trench drain, which is located inside the first lane of the running track, is filled with debris and clogged. This condition will inhibit drainage and accelerate the deterioration of the resilient surface and asphalt base. 3) The facility is not ADA compliant. To be ADA compliant the facility needs an “accessible route” from the parking area to the track, field, and spectator areas. This route should be a paved surface with a minimum of 4’ width.

17. WEST 'D' AREA: THE WEST 'D' AREA WAS ALSO INSTALLED DURING 2013 AND IS USED FOR THE LONG-TRIPLE JUMP EVENTS. THE PAVEMENT IS SETTLING AROUND THE JUMPING EVENTS AND SHOULD BE REMOVED/REBUILT WHEN THE 400M RUNNING TRACK SURFACE IS RECONSTRUCTED.

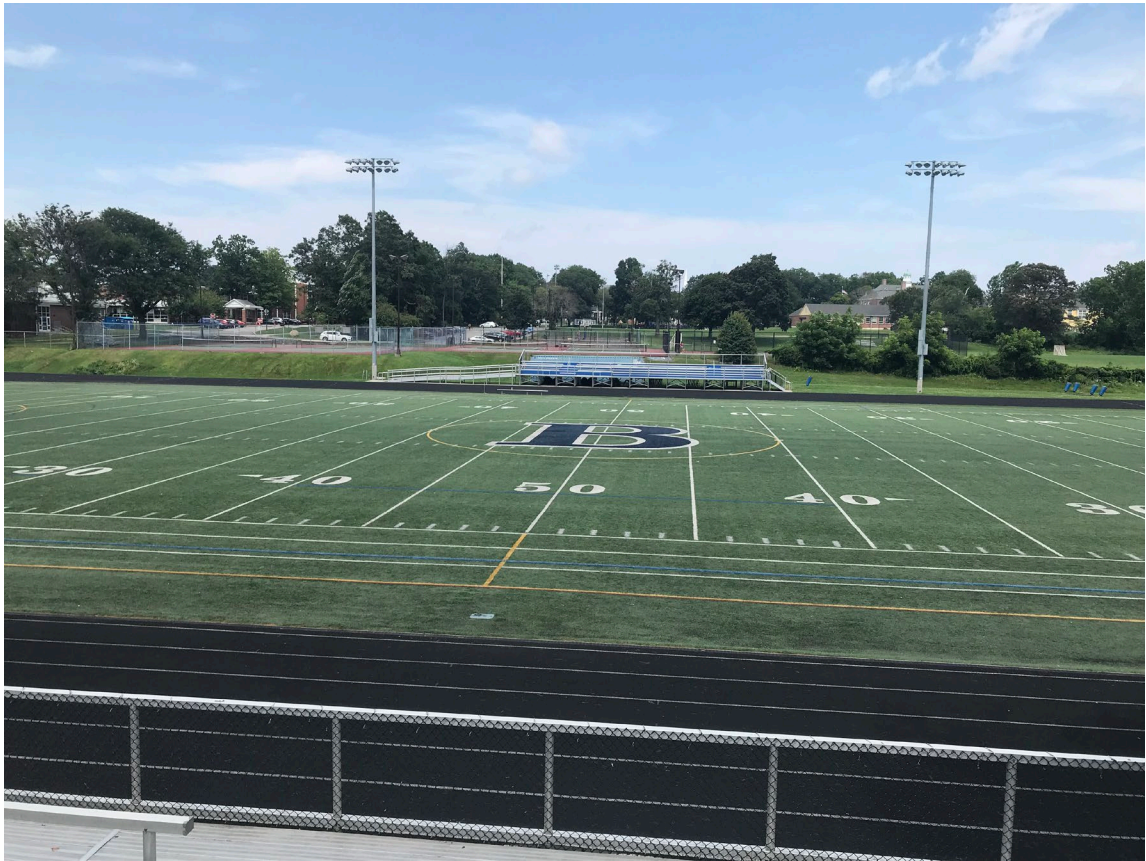
Figure 5 – Multi-purpose Field

2. **Multi-Purpose Synthetic Turf Field:** The multi-purpose synthetic turf field was installed in the summer of 2013. The field appears to be a dual fiber system with sand and SBR crumb rubber infill. We were informed that the field does not currently have a resilient shock pad. The field accommodates football, soccer, field hockey, and lacrosse as a varsity game field. The field is supported by irrigation, grandstands, a pressbox, sports lighting, and a concession stand. The field is oriented in an east-west direction.

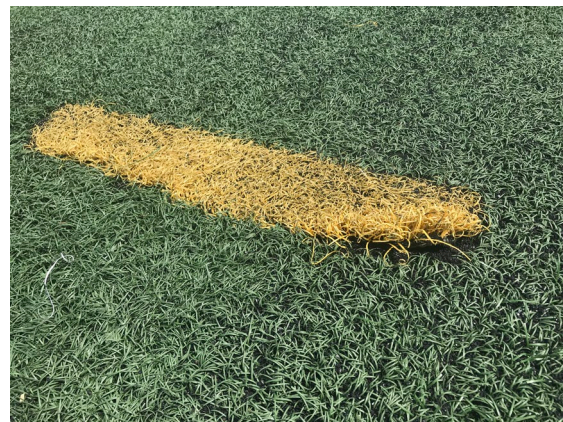
Figure 7 – Synthetic Turf Seam Failure

Observations made at the time of our site inspection include the following: 1) The synthetic turf field is nearing the end of its useful life. Displaced and broken fiber are evident throughout the body of the field. Loose seams are also evident in several locations. Refer to photos above and attached for additional information.

14. THE EXISTING SYNTHETIC TURF FIELD WAS INSTALLED IN 2013 AND IS NEARING THE END OF ITS USEFUL LIFE. LOOSE AND BROKEN TURF FIBERS ARE EVIDENT THROUGHOUT THE PLAYING SURFACE. THE OWNER SHOULD REPLACE THE EXISTING SURFACE WITHIN THE NEXT TWO (2) YEARS. REFER TO OUR LETTER REPORT AND PHOTOS FOR ADDITIONAL INFORMATION.

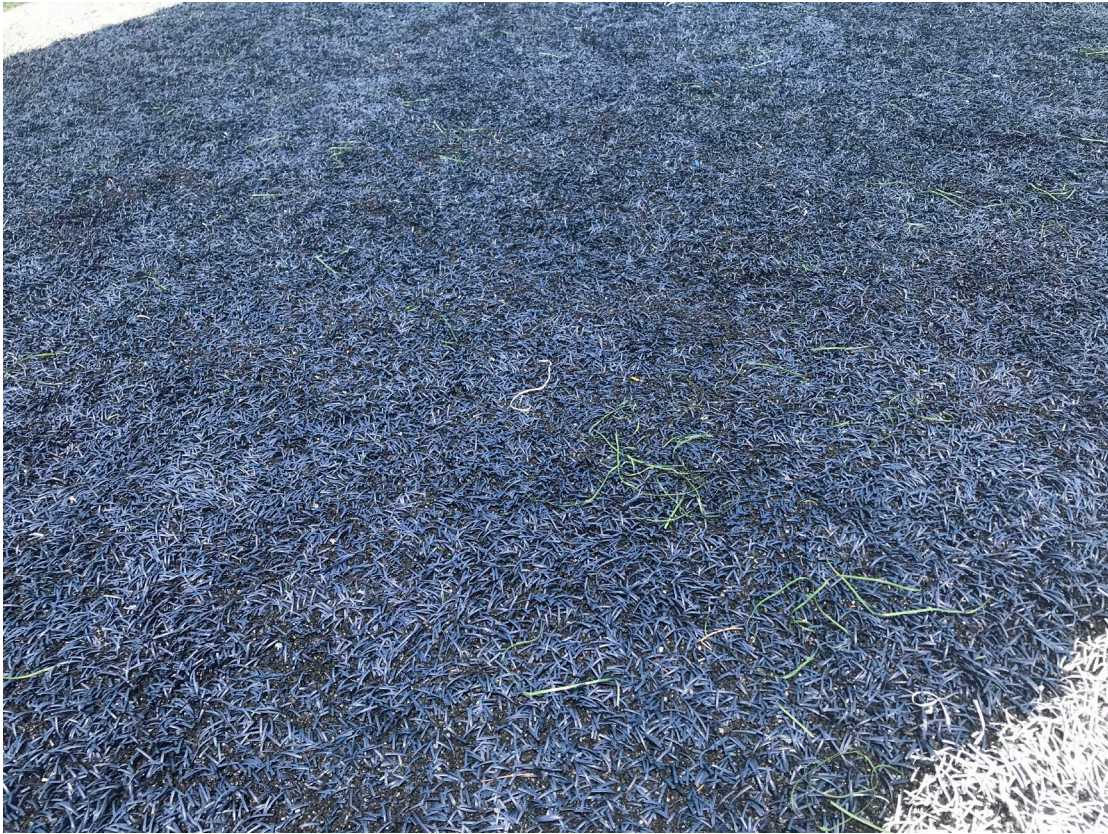
Figure 8 – Dislodged fibers are event throughout the field.

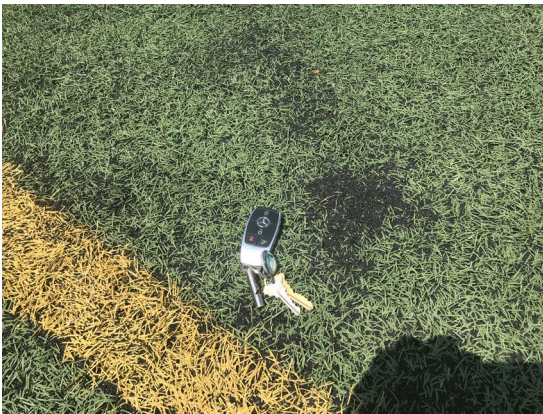
Figure 8(a) – Fiber wear & exposed infill

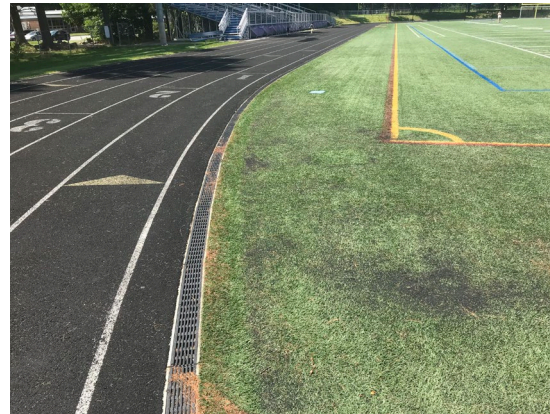
Figure 8(b) – Fiber wear & exposed infill

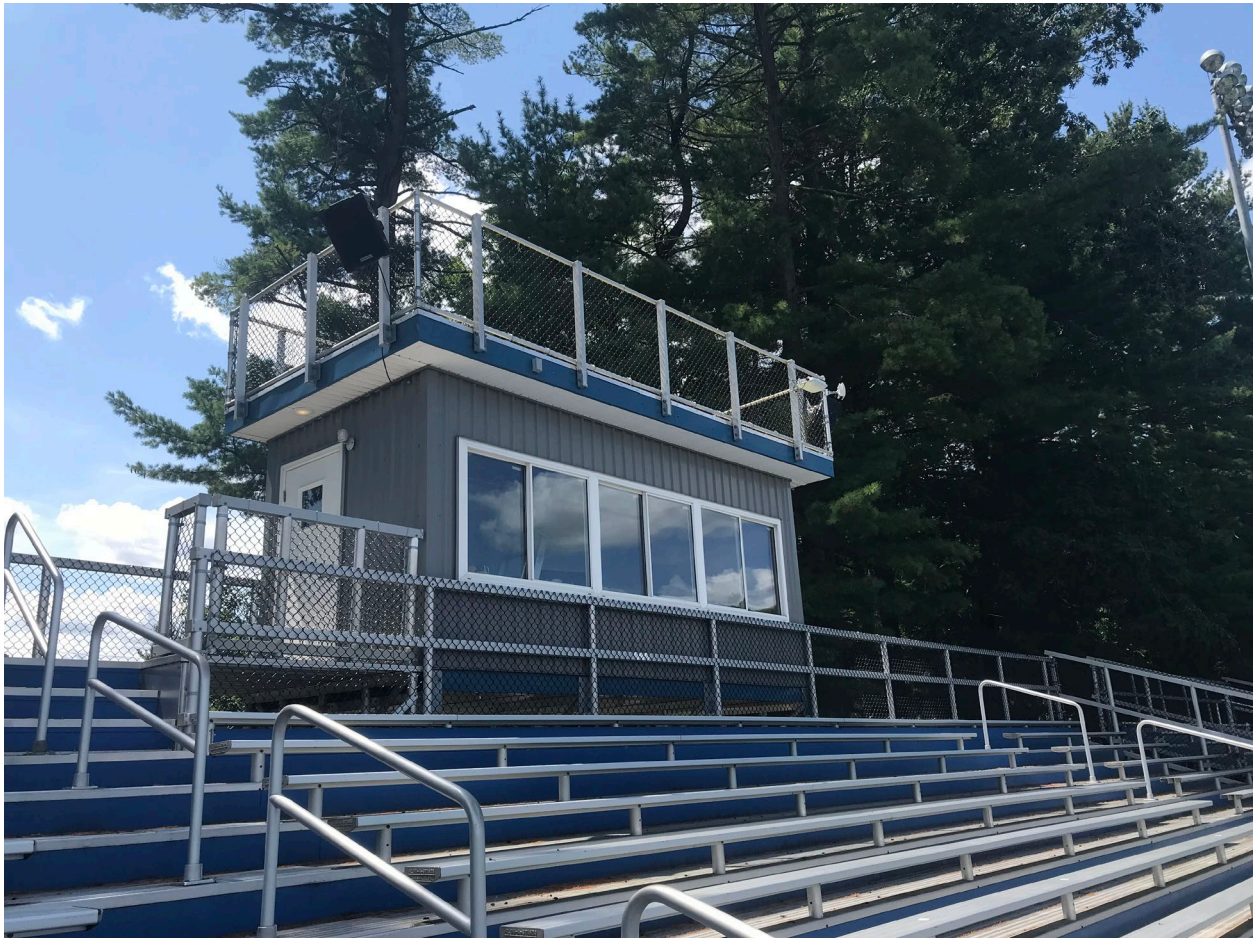
Figure 9 – Home Grandstand & Pressbox.

3. **Home Grandstands:** The home grandstand was manufactured by Dant Clayton, contains approximately 600 seats, and was installed in 2001. The bleacher itself is compliant with ADA requirements, however, the following issues should be addressed:
 - a. The landing at the bottom of the east stairs should be extended to be in full compliance. ADA codes require that a landing must be provided at the top and bottom of each

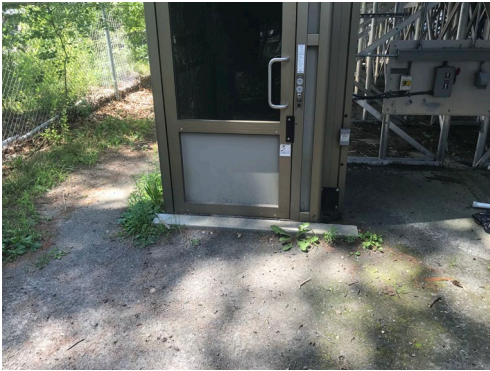
- b. Several end caps on the seat planks are missing. Additional end caps should be installed to minimize exposure to sharp edges.
- c. The walkway to the handicapped lift servicing the pressbox is also not accessible and should be paved, with a smooth surface. The handicapped lift is not accessible given that the existing granite curb at the base of the lift provides a 1" step up into the lift enclosure.
- d. The site access from the John Glenn Middle School on the adjacent McMahon Street, located just behind the grandstand, is also not accessible. To be considered accessible the sloped walkways should not exceed 5% in grade or include a ramp at not more than 8% with handrails and landing areas. The present walkway is more than 12% in grade.

Figure 10 – Granite curb at HC Lift

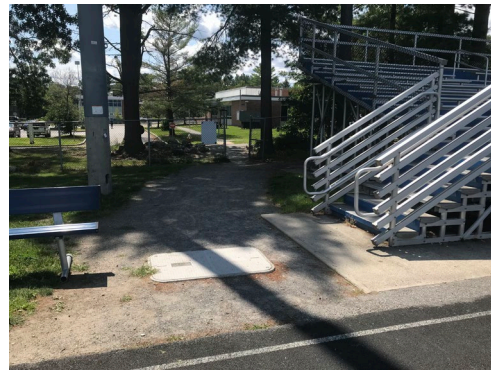
stairway. The landing should be at least as wide as the stairway that it serves. The length (measured in the direction of travel) should be greater or equal to the width. In this case, the length of the landing should be at least 4' in length. The bottom few steps also have too much deflection when weight is applied. The owner should review and repair the steps as necessary.

Figure 11 – Existing Stair Landing

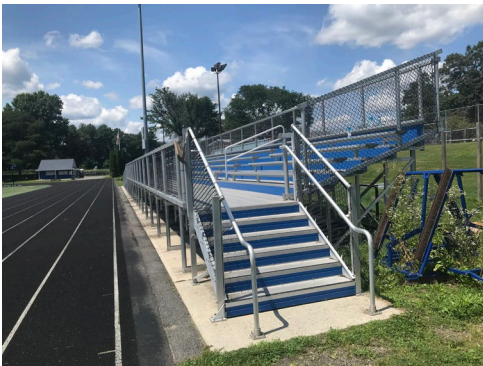
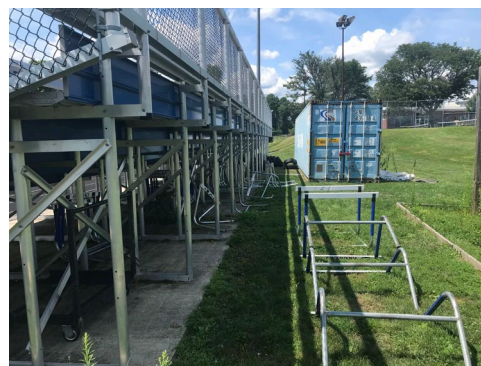
4. **Visitor Grandstands:** The visitor grandstand was manufactured by Dant Clayton, contains 221 seats, and was installed in 2014. The bleacher itself is compliant with ADA requirements, however, the landing at the bottom of the east stair should be extended to be in full compliance. ADA codes require that a landing must be provided at the top and bottom of each stairway. The landing should be at least as wide as the stairway that it serves. The length (measured in the direction of travel) should be greater or equal to the width. In this case, the length of the landing should be at least 4' in length. Several end caps on the seat planks are missing. Additional end caps should be installed to minimize exposure to sharp edges.

Figure 12 – Visitor Grandstands

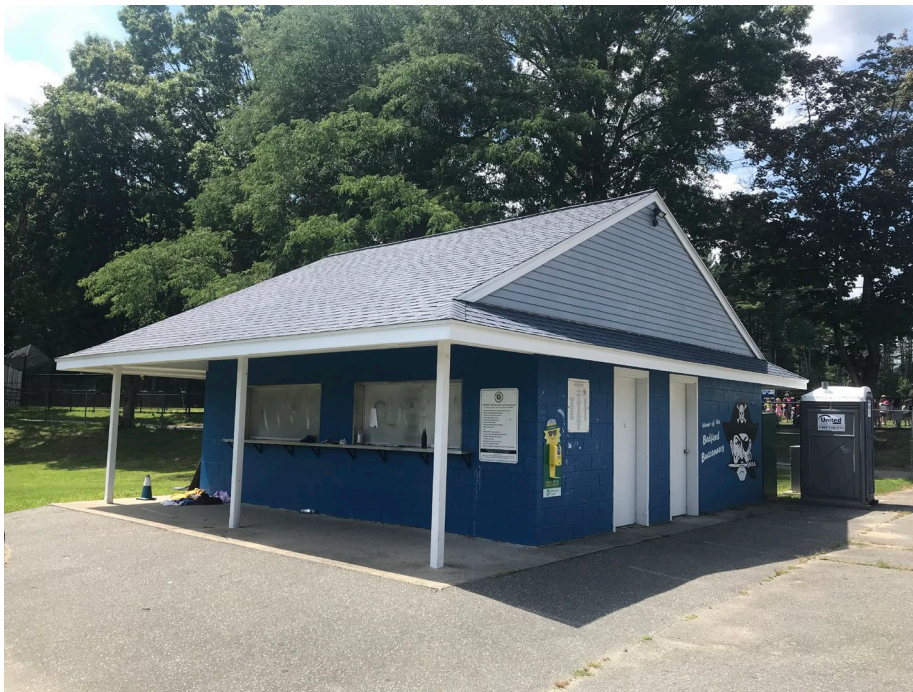
Figure 16 – Concessions & Storage Building

5. **Concessions & Storage Building:** The concessions and storage building contains approximately 700 square feet, divided evenly between the concessions and storage area. The exact date of construction is unknown, but the building appears to have been built prior to 2001. The building is serviced with both water and electric power, **the availability of sewer service needs to be confirmed in the field.**

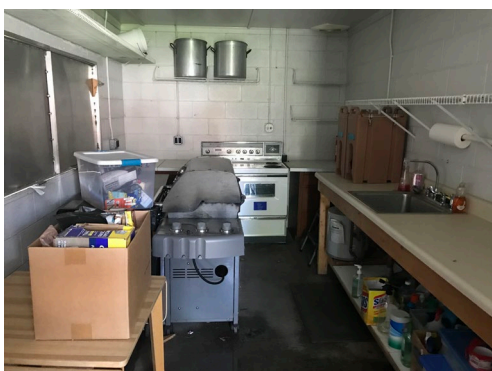
Figure 17 – Concessions Area

- a. The cooking area appears to be set up to service pre-purchased items including water, soft drinks, coffee, and other hot drinks. We were informed during our visit that the user groups may also serve pizza and hot dogs which are cooked elsewhere and warmed and served in the building.

- b. The serving windows are not ADA-compliant. An ADA-compliant counter should be at least 36" long and no more than 36" from the finished grade.
 - c. There is an old stove top and oven in the cooking area that does not appear to function. This stove should be removed.

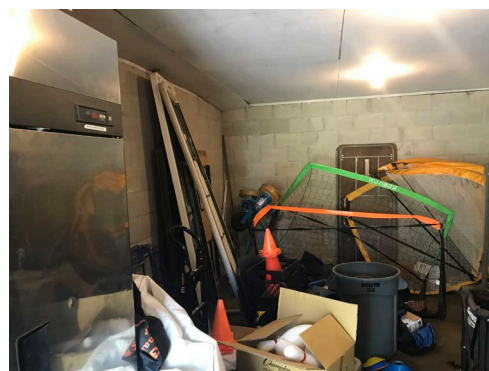
Figure 18 – Storage Area

- d. The storage area provided limited access and could benefit from a clean-out and reorganization.
 - e. There are no bathroom facilities in the concession/storage building.

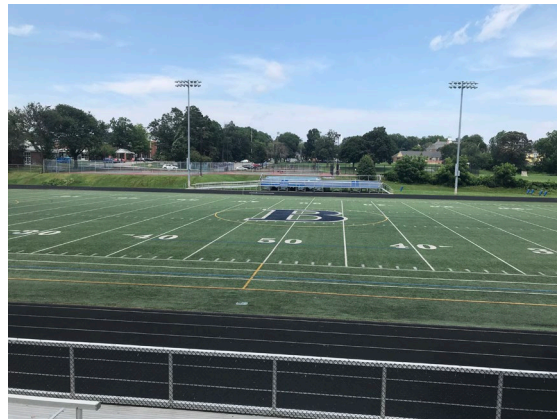
Figure 20 – Sports Lighting

7. **Sports Lighting:** The existing sports lighting is a four-pole system manufactured by Musco Sports Lighting and was installed in 2004. The light poles are approximately seventy feet (70') in height and contain fourteen (14) fixtures on each pole. **The foot-candle reading is not available at this time. HAI to confirm with Musco for the final report.** Conversion to an updated LED system would reduce energy consumption by up to 40% of the current demand.

13. THE EXISTING SPORTS LIGHTING IS AN OLDER TECHNOLOGY. THE TOWN SHOULD CONSIDER UPGRADING THE LIGHT FIXTURES TO LED COMPONENTS. A CHANGE TO LED WILL RESULT IN APPROXIMATELY 40% REDUCTION IN ENERGY CONSUMPTION. THE EXISTING SPORTS LIGHT POLES AND TRANSFORMERS CAN REMAIN IN PLACE.

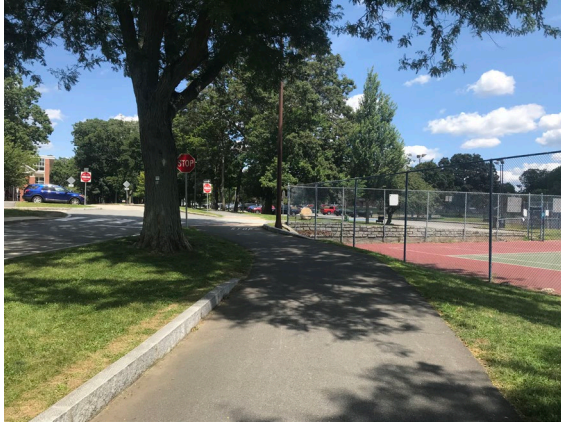
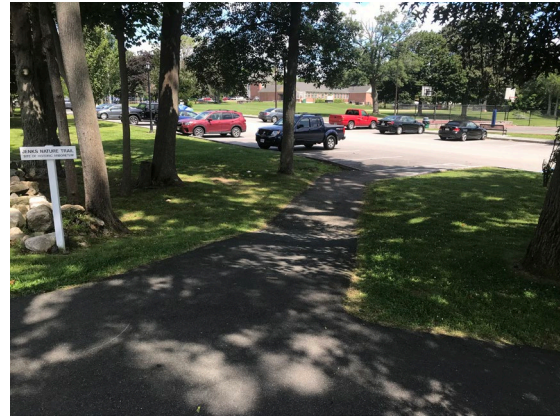
8. **Parking & Walkways:** There are presently two locations available to gain access to the track & field facility. The first is from the north, parking at Bedford High School and walking down to the stadium. The path from the High School parking area down to the stadium is not ADA-compliant. The grades exceed 5% and the location of handicapped parking dedicated to the facility is not immediately obvious.

Figure 21 – Accessible Route to the HS.

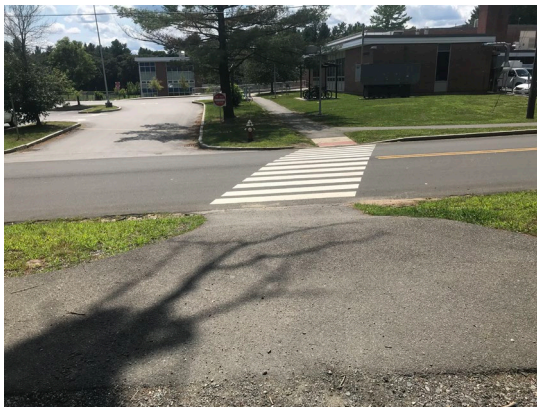
The second location is south of the existing facility, from the John Glenn Middle School on McMahon Road. There are gates from the Middle School to the field on both sides at the rear of the home grandstand. The access on the west side of the grandstand appears to meet the requirements for grade and slope. The access on the east side of the stadium is too steep and does not presently meet ADA codes.

Figure 23 – McMahon Road - East Entry

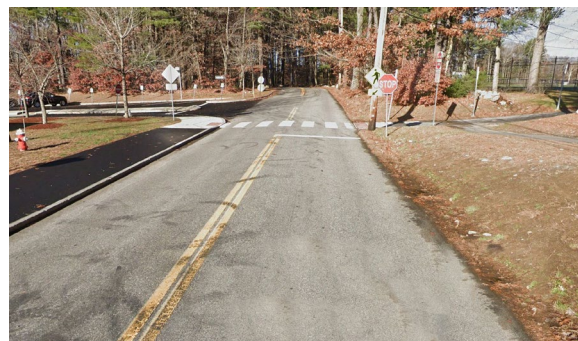
Figure 24 – McMahon Road - West Entry

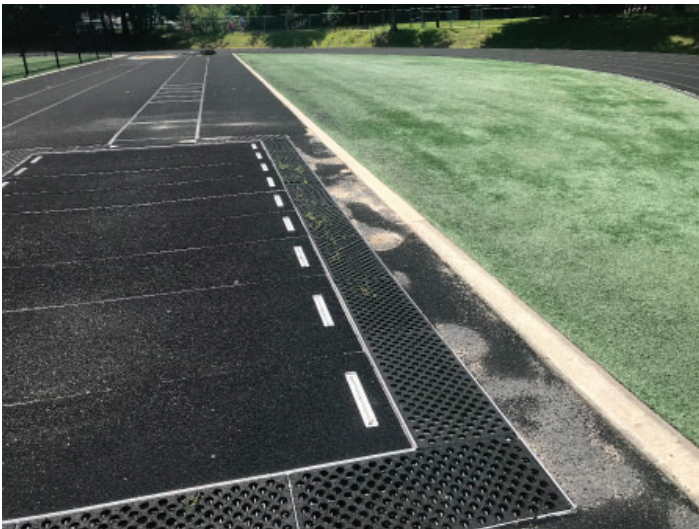
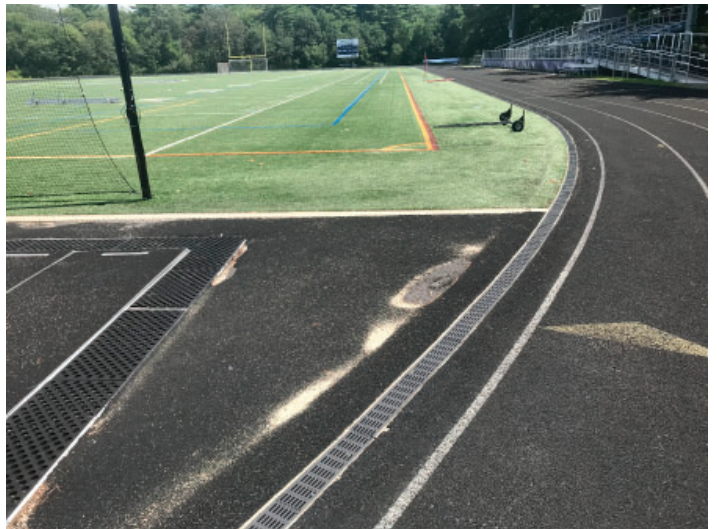
Photo 9 - Jump Pit - Settlement

Photo 10 - Jump Pit - Settlement

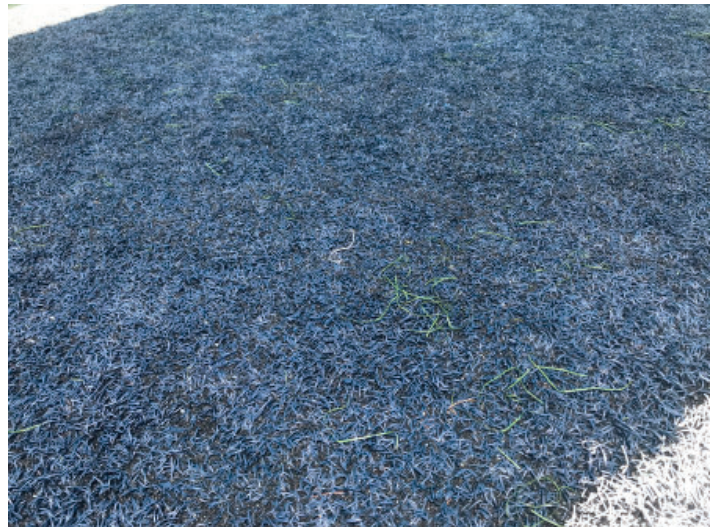
Photo 16 - Turf Field - Loose Fiber

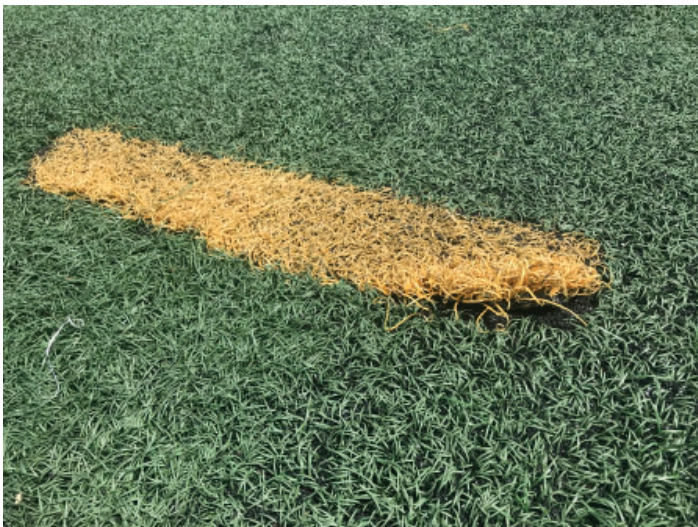
Photo 17 -Turf Field - Loose Seam

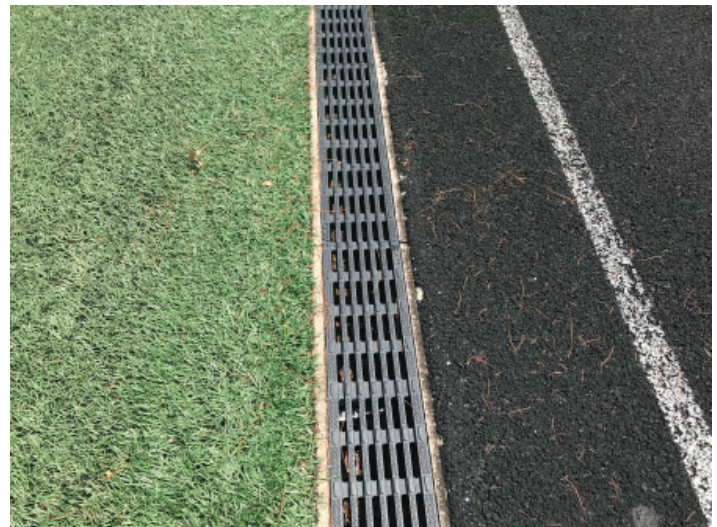
Photo 18 - ACO Trench Drain - Full of Debris

18. THE TRENCH DRAIN SURROUNDING THE FIELD IS CLOGGED WITH DEBRIS AND SHOULD BE JET CLEANED. ALL CATCH BASINS AND SUMPS CONNECTED TO THE DRAINAGE SYSTEM SHOULD ALSO BE INSPECTED AND CLEANED AS NECESSARY.

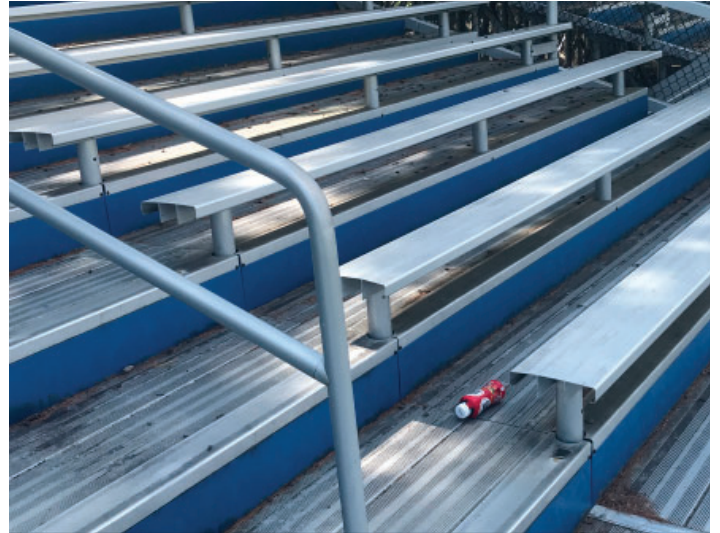
Photo 26 - Existing Home Bleacher - Missing End Caps

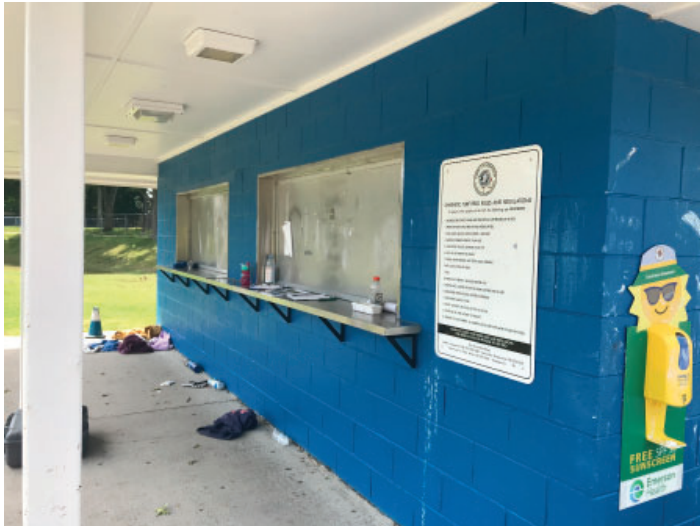
Photo 37 - Existing Serving Windows

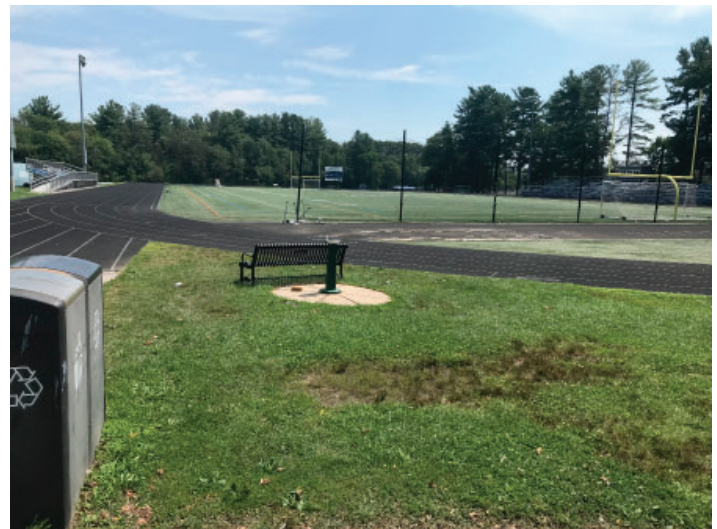
- f. The water bubbler just east of the concession building is not functioning. It is important to provide potable water near the field for athletes and coaches who use the facility. We recommend that the water bubbler be repaired or replaced at your earliest convenience.

Photo 42 - Existing Water Bubblers
