SABOURIN STADIUM

Bedford High School
400m Track & Field Complex Master Plan

August 22, 2023
DRAFT

Re: Bedford Sabourin Field Complex – Master Plan

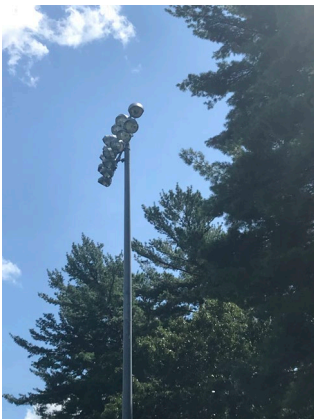
7. **Sports Lighting:** The existing sports lighting is a four-pole system manufactured by Musco Sports Lighting and was installed in 2004. The light poles are approximately seventy feet (70') in height and contain fourteen (14) fixtures on each pole. **The foot-candle reading is not available at this time. HAI to confirm with Musco for the final report.** Conversion to an updated LED system would reduce energy consumption by up to 40% of the current demand.

Figure 19 – Sports Lighting

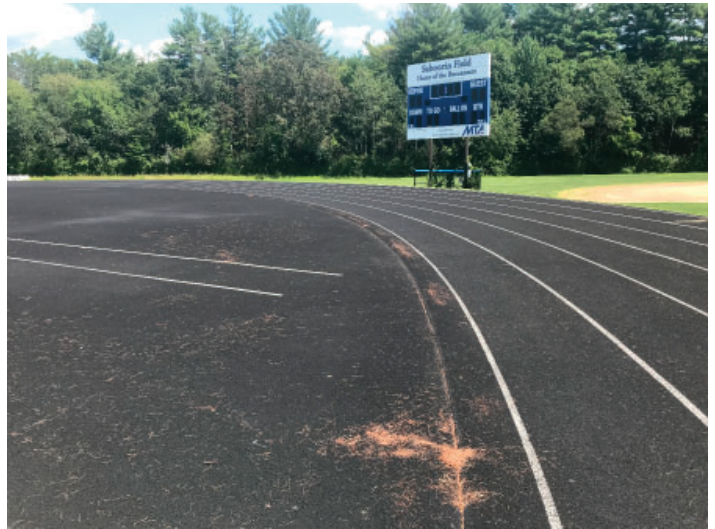
Photo 2 - 400m Track - 'D' Area

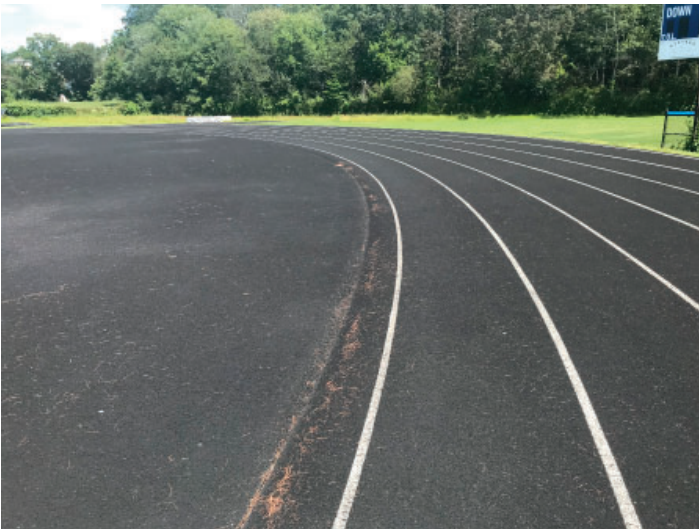
Photo 3 - 400m Track - 'D' Area

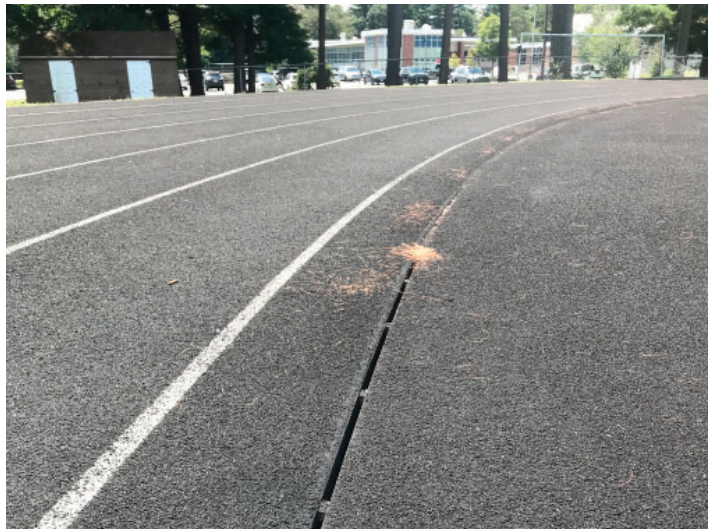
Photo 4 - 400m Track - 'D' Area

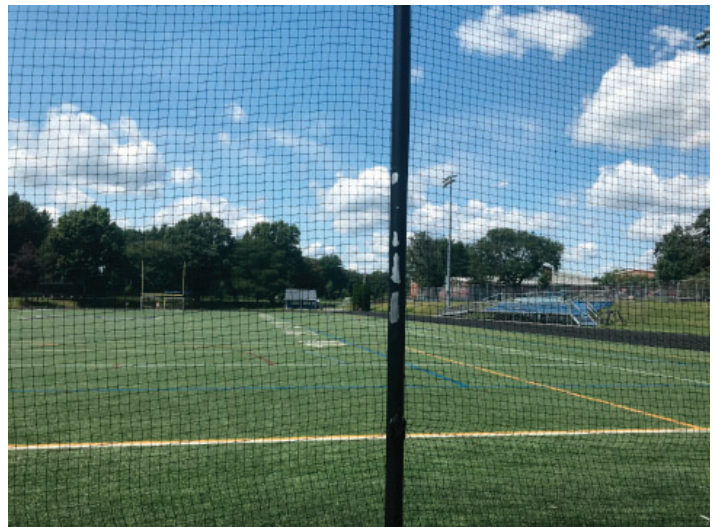
Photo 6 - Existing Safety Netting & Post

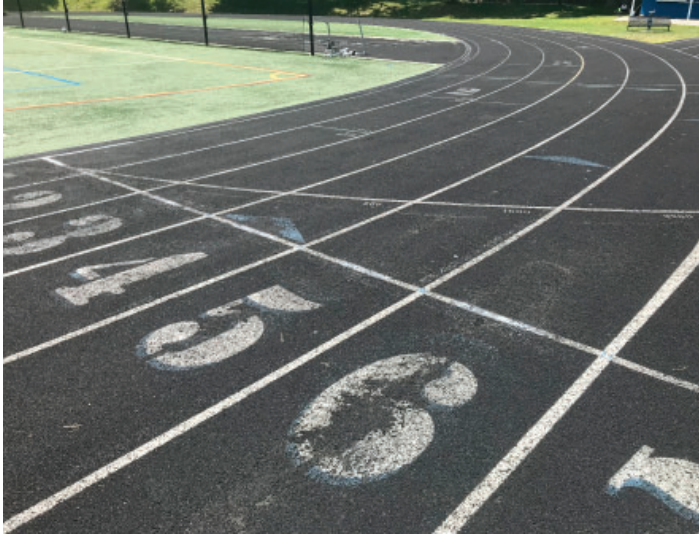
Photo 7 - Existing Track Surface

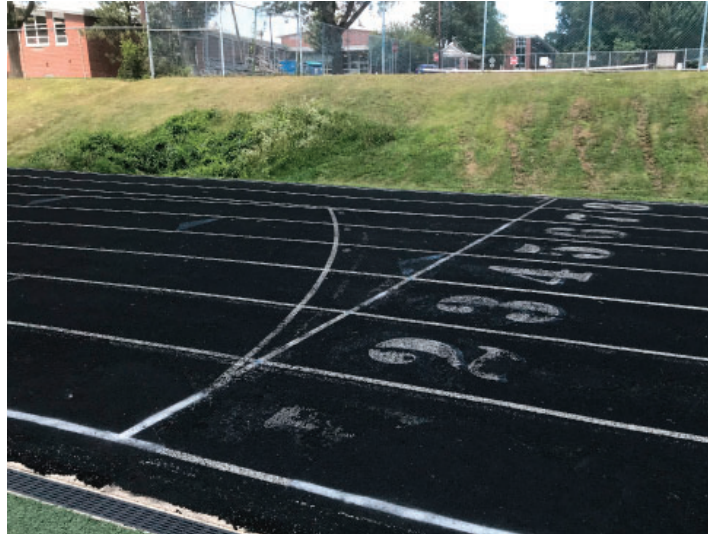
Photo 8 - Existing Track Surface

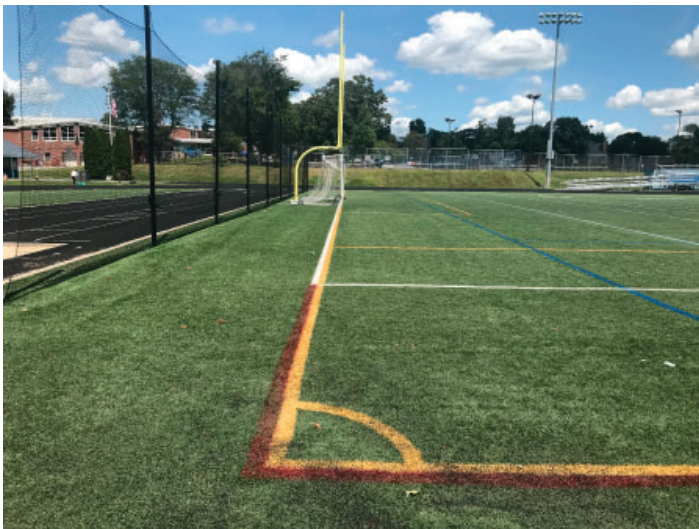
Photo 11 - Turf Field - End Lines

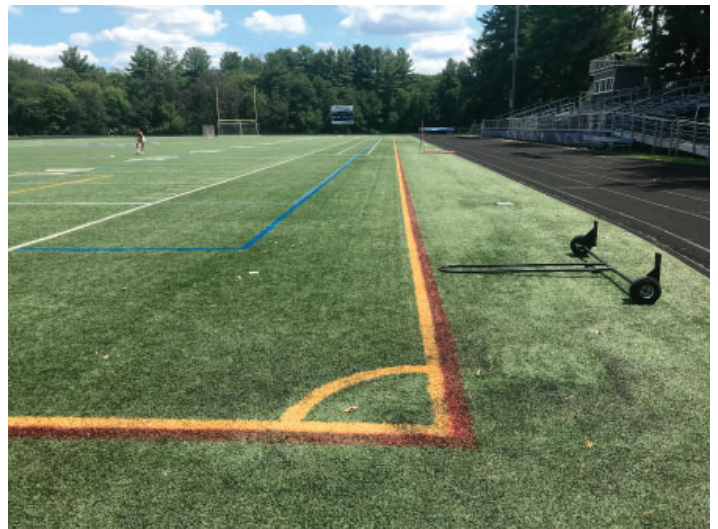
Photo 12 - Turf Field - Sidelines

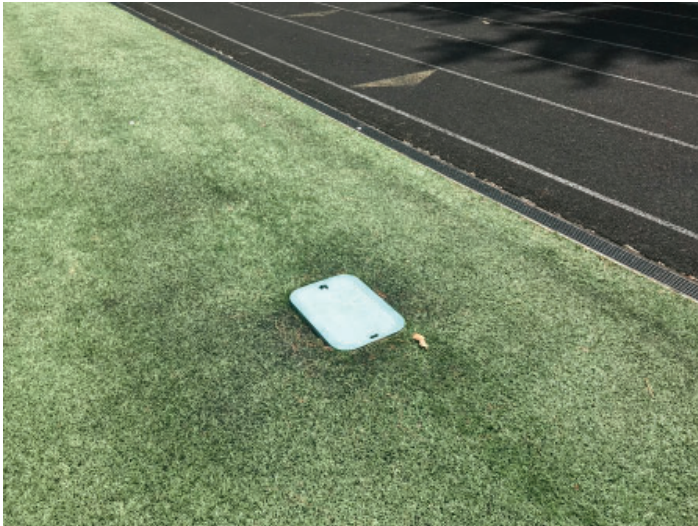
Photo 13 - Turf Field - Irrigation Handhole

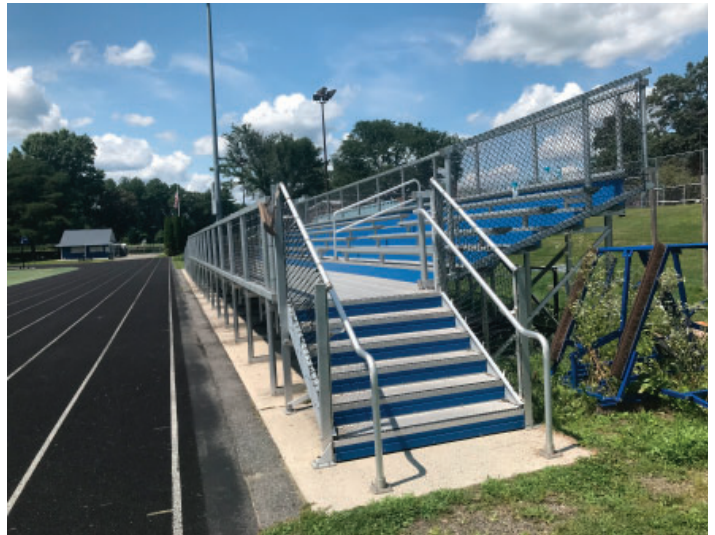
Photo 20 - Existing Visitor Bleacher - Access

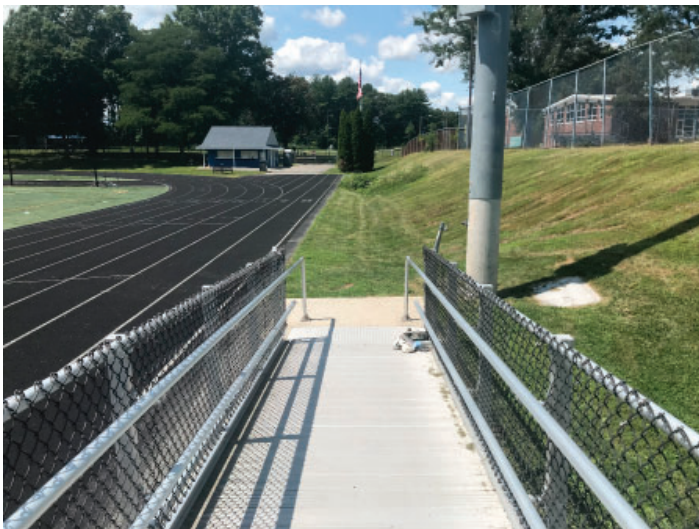
Photo 23 - Existing Visitor Bleacher - Access

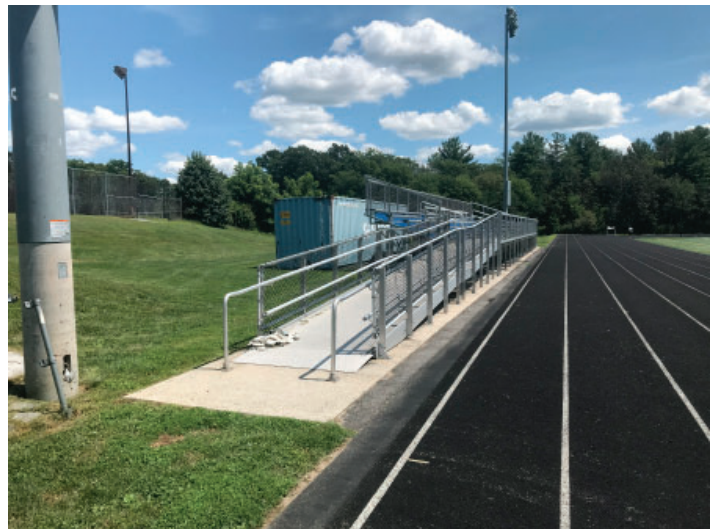
Photo 24 - Existing Visitor Bleacher - Access

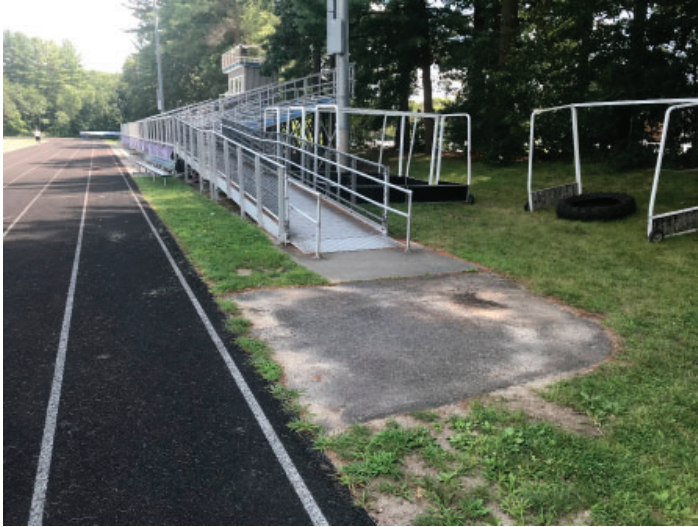
Photo 25 - Existing Home Bleacher - Access

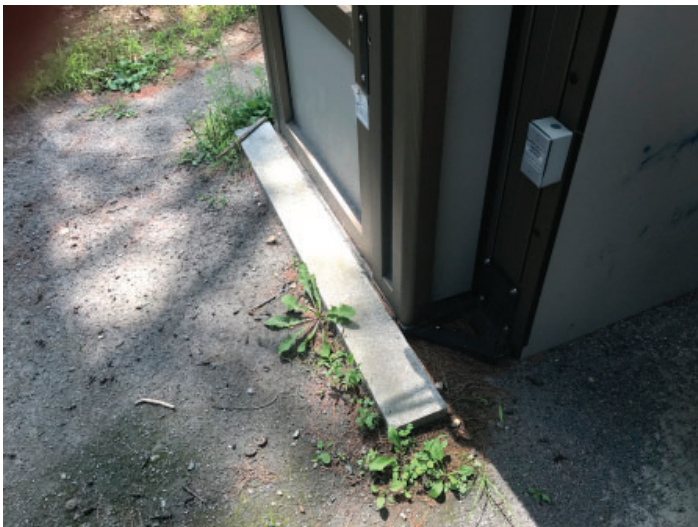
Photo 29 - Existing Home Bleacher - HC Lift

- b. Several end caps on the seat planks are missing. Additional end caps should be installed to minimize exposure to sharp edges.
- c. The walkway to the handicapped lift servicing the pressbox is also not accessible and should be paved, with a smooth surface. The handicapped lift is not accessible given that the existing granite curb at the base of the lift provides a 1" step up into the lift enclosure.
- d. The site access from the John Glenn Middle School on the adjacent McMahon Street, located just behind the grandstand, is also not accessible. To be considered accessible the sloped walkways should not exceed 5% in grade or include a ramp at not more than 8% with handrails and landing areas. The present walkway is more than 12% in grade.

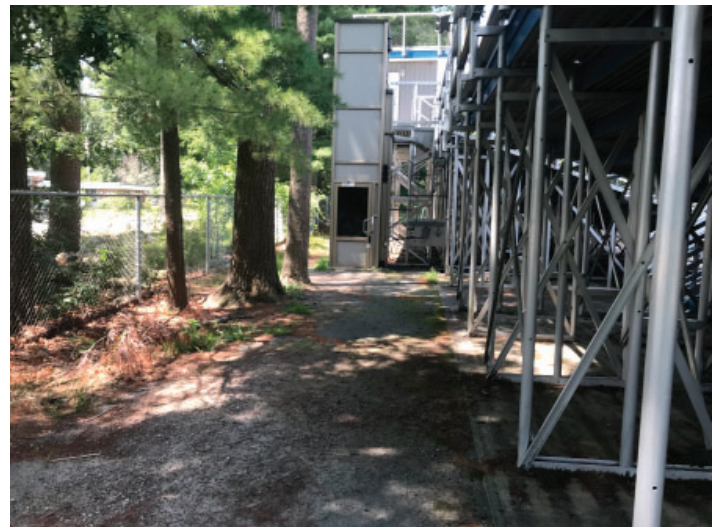
Photo 30 - Existing Home Bleacher - HC Lift

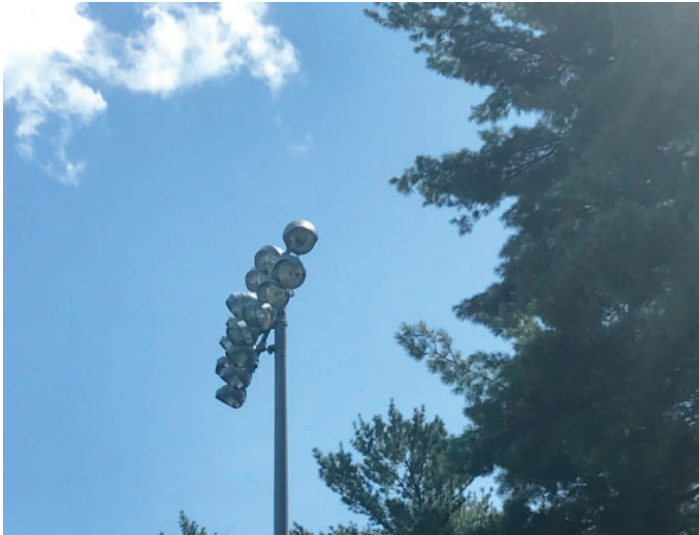
Photo 31 - Existing Sports Lighting - MUSCO.

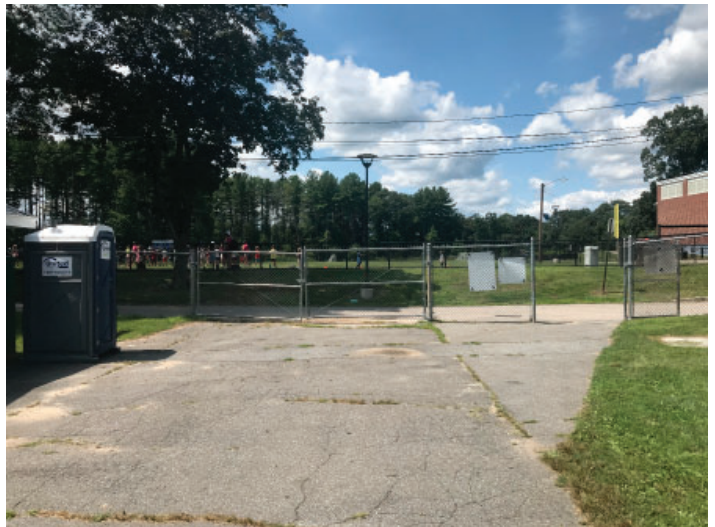
Photo 34 - Existing Pedestrian Access

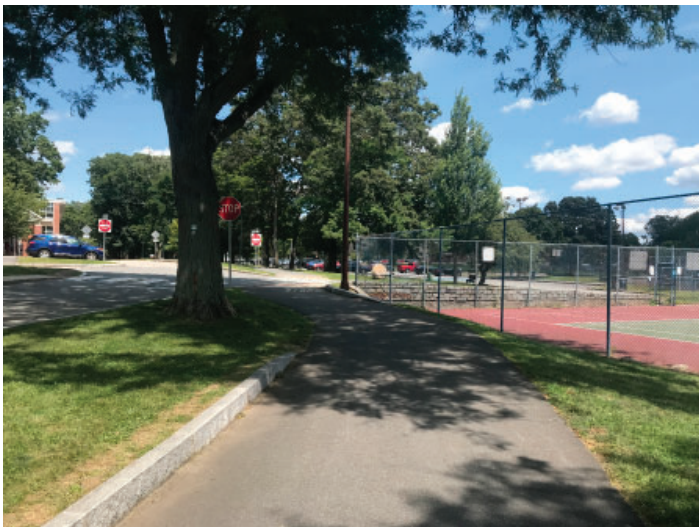
Photo 35 - Existing Pedestrian Access

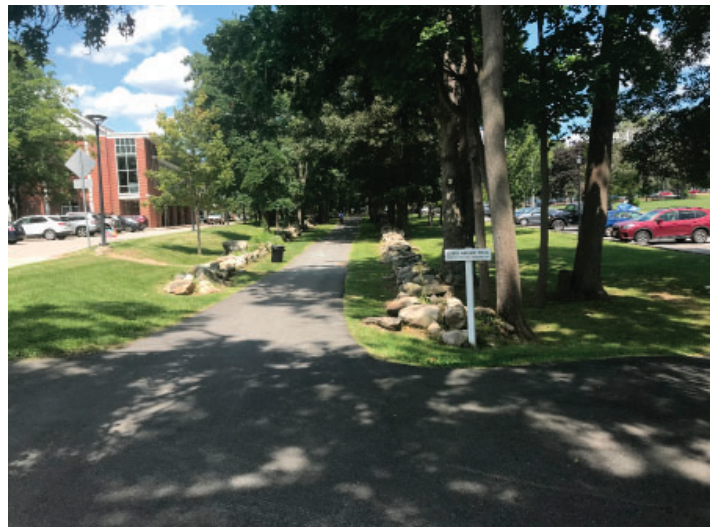
Photo 36 - Existing Pedestrian Access
